MISCELLANEOUS PAPER CERC-84-2

BREAKAGE OF CONCRETE ARMOR UNITS; SURVEY OF EXISTING CORPS STRUCTURES

Dennis G. Markle, D. Donald Davidson
Coastal Engineering Research Center
U. S. Army Engineer Waterways Experiment Station
P. O. Box 631, Vicksburg, Miss. 39180

March 1984
Final Report

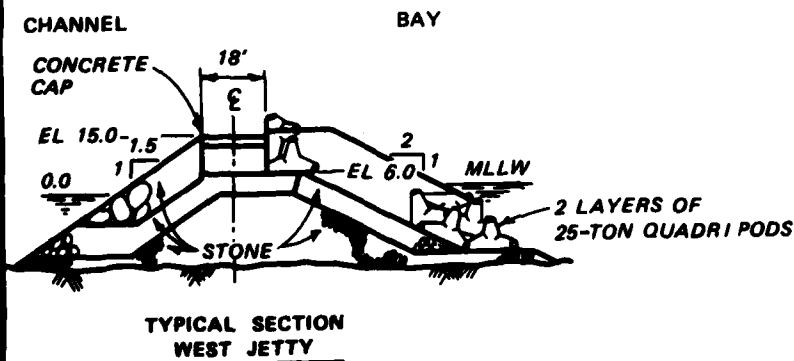
TYPICAL BREAKWATER SECTION

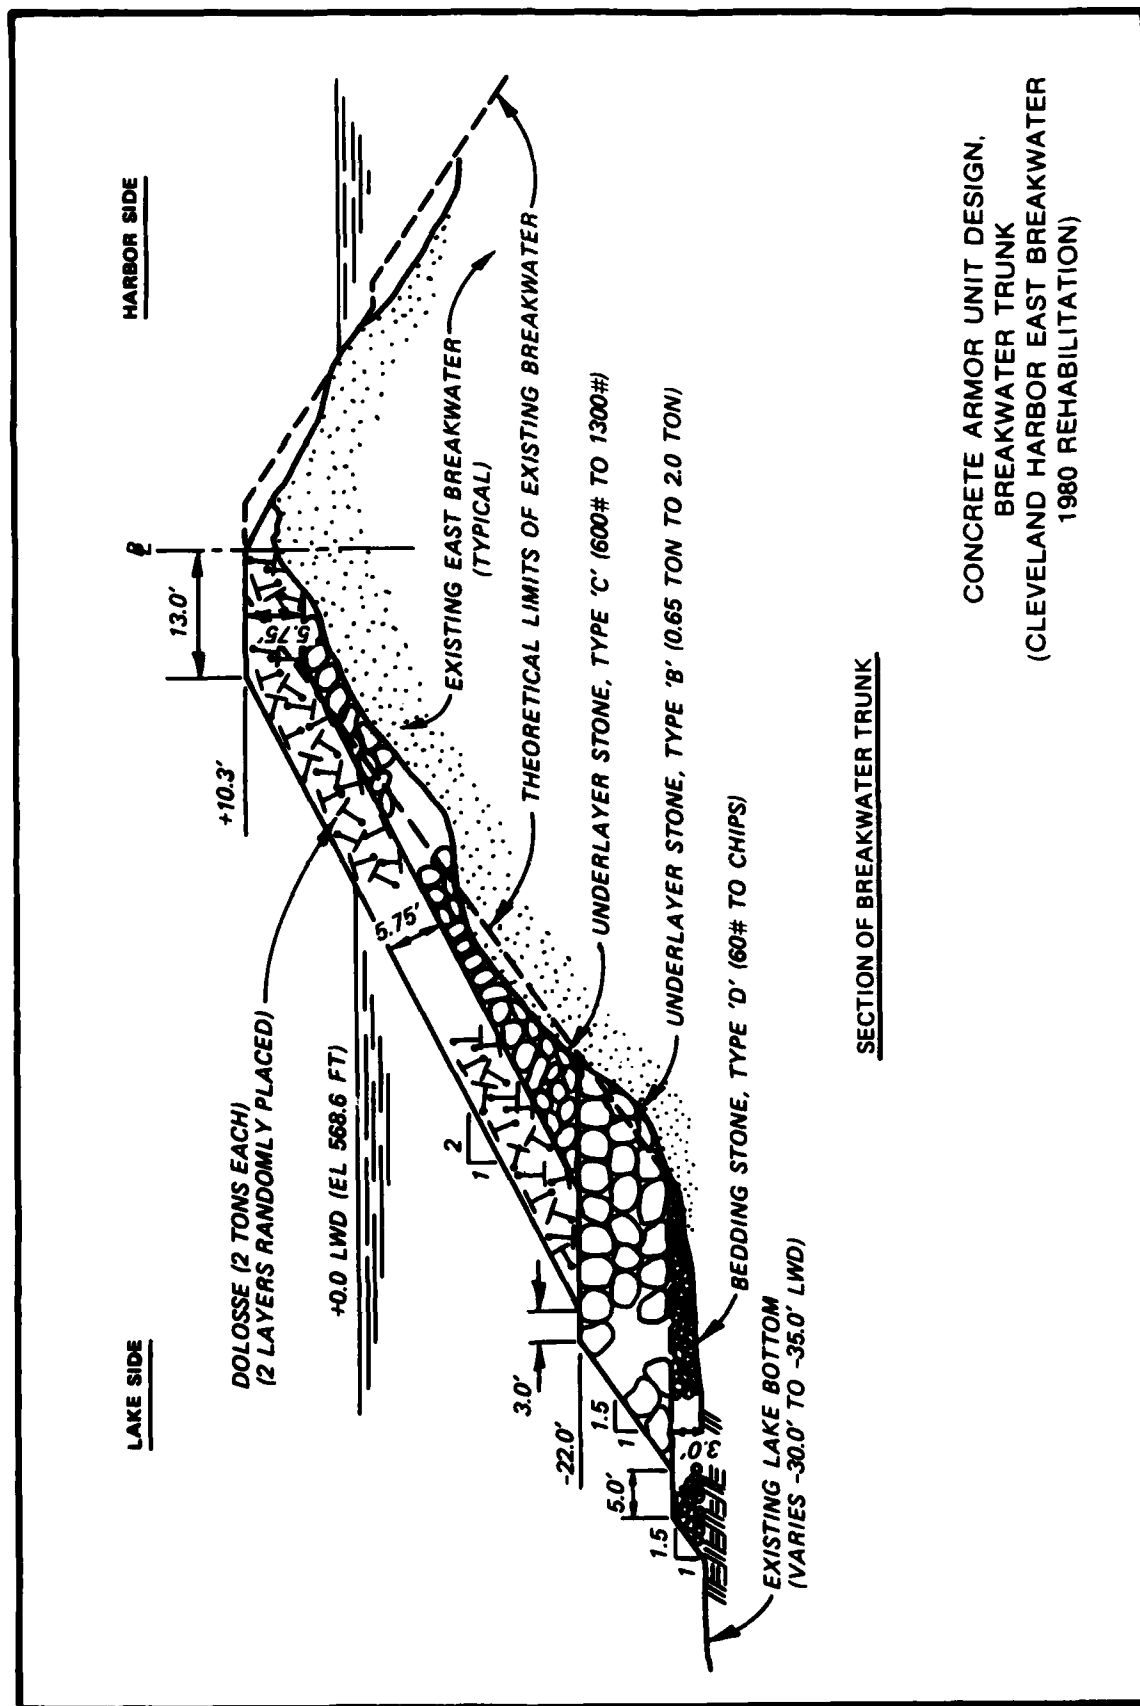
CONCRETE ARMOR UNIT DESIGN,
BREAKWATER TRUNK
(CLEVELAND HARBOR EAST BREAKWATER
1980 REHABILITATION)

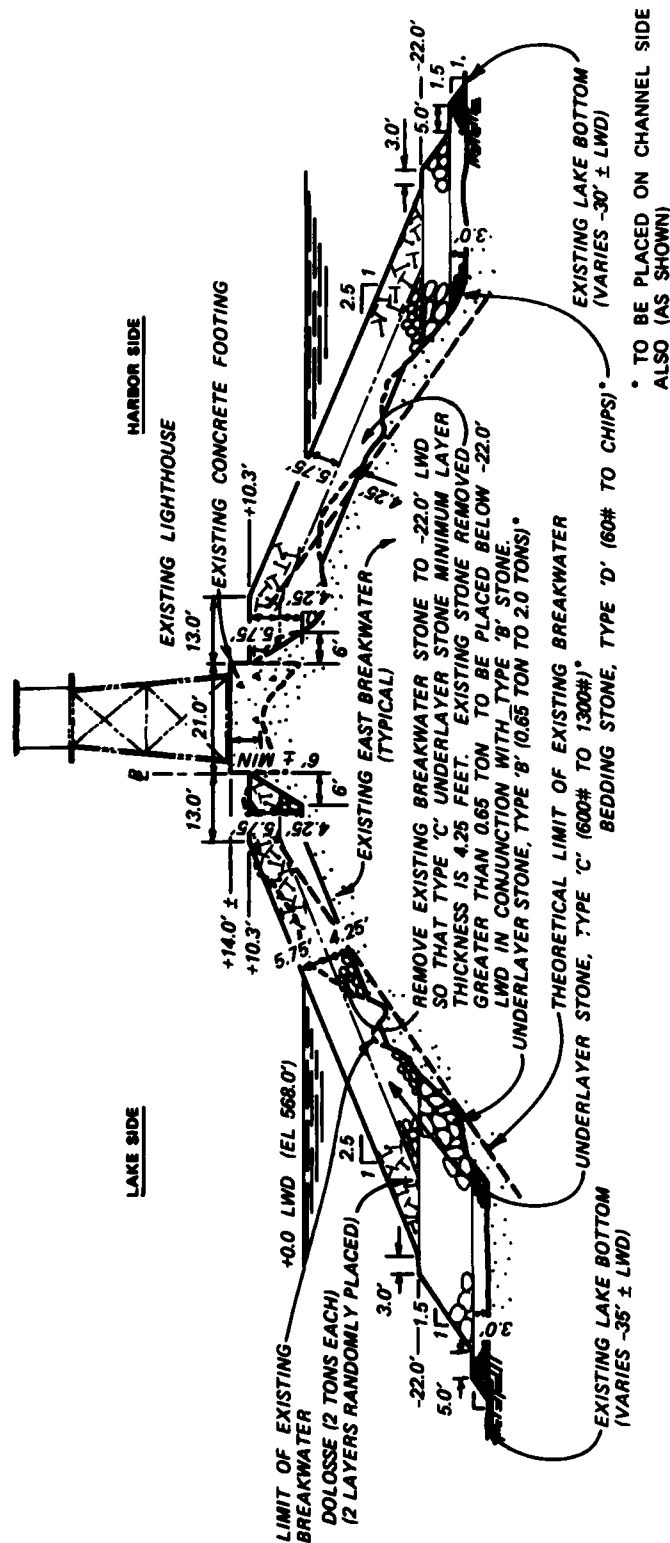
SECTION OF BREAKWATER HEAD

CONCRETE ARMOR UNIT DESIGN,
BREAKWATER HEAD
(CLEVELAND HARBOR EAST BREAKWATER
1980 REHABILITATION)
